# Manhole Inspection Summary

Manhole # S31UU1008MH

Insp Date: **1/16/07 11:54 AM**

**Location** Address: **5001 SAINT ALBANS WAY**

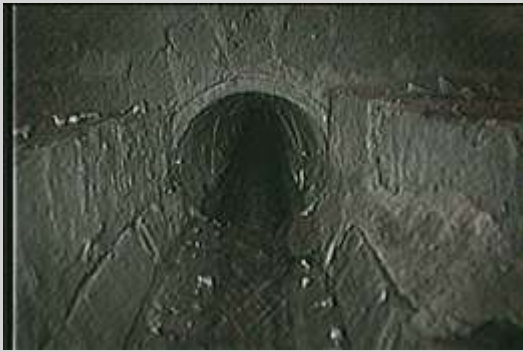
### 8 in. Circular Gravity Sewer

Rod and Bar (Angled)

Pipe Material: **Clay** ☐ Pipe Lined

Infiltration: **None** Pipe Seal Cond: **Unknown**
